REPAIR, EVALUATION, MAINTENANCE, AND
REHABILITATION RESEARCH PROGRAM

TECHNICAL REPORT REMR-CO-1

STABILITY OF RUBBLE-MOUND
BREAKWATER AND JETTY TOES;
SURVEY OF FIELD EXPERIENCE

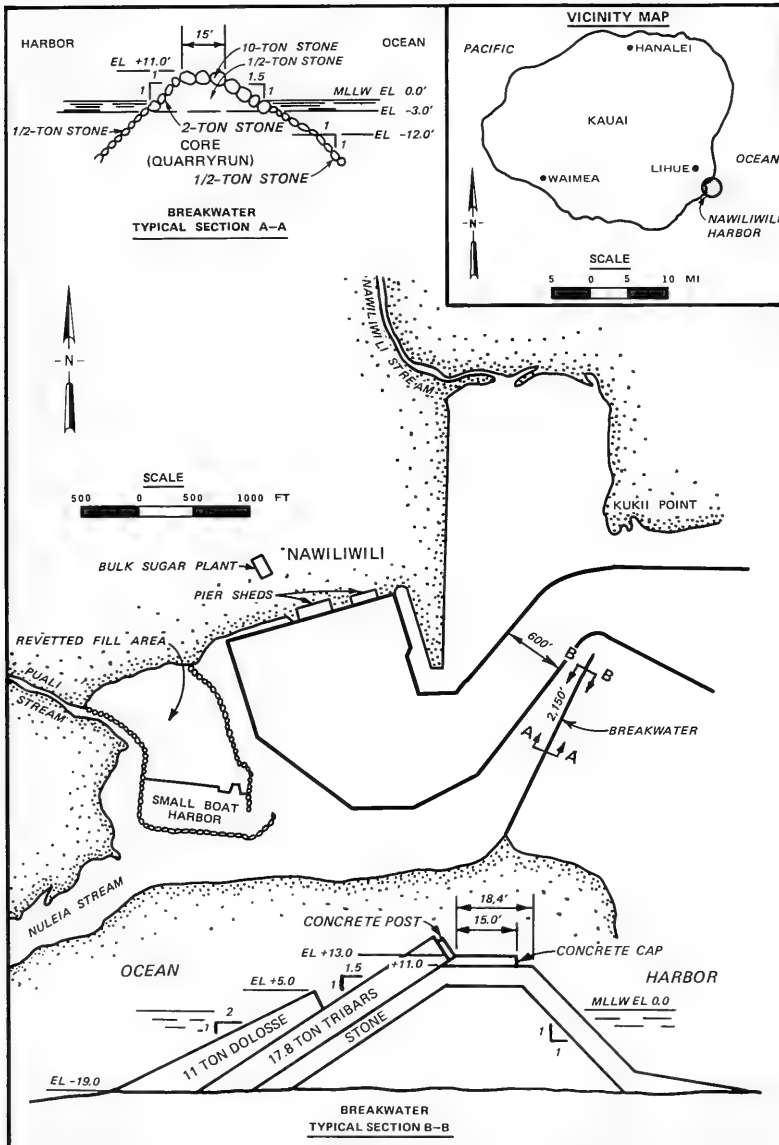
Figure 1. Nawiliwili Harbor Breakwater, Kauai, Hawaii

10. The Honolulu District of POD has three breakwaters which have problems and/or design questions that are related to toe stability. Two of the structures, Nawiliwili and Hilo, had a related problem. The head and adjacent 500 ft* of breakwater trunk at Nawiliwili Harbor, Kauai, Hawaii (Figure 1), were rehabilitated in 1959 using 17.8-ton tribars. Model

tests*, conducted at WES in 1958, revealed that two layers of randomly placed tribars on the head and one layer of uniformly placed tribars on the trunk were the best methods of rehabilitating the storm damaged structure. A survey in 1975 revealed extensive tribar breakage, and later it was found that the toe buttressing stone recommended for placement at the toe of the one layer of uniformly placed tribars had not been incorporated into the construction specifications. It was surmised that in the absence of these buttressing stones the tribar toe slid on the hard bottom which resulted in an en masse slippage and breakage of several tribars. This area was rehabilitated with two layers of randomly placed 11-ton dolosse on slope and through the use of special placement of the toe dolosse. This latter work was also model-tested at WES.**

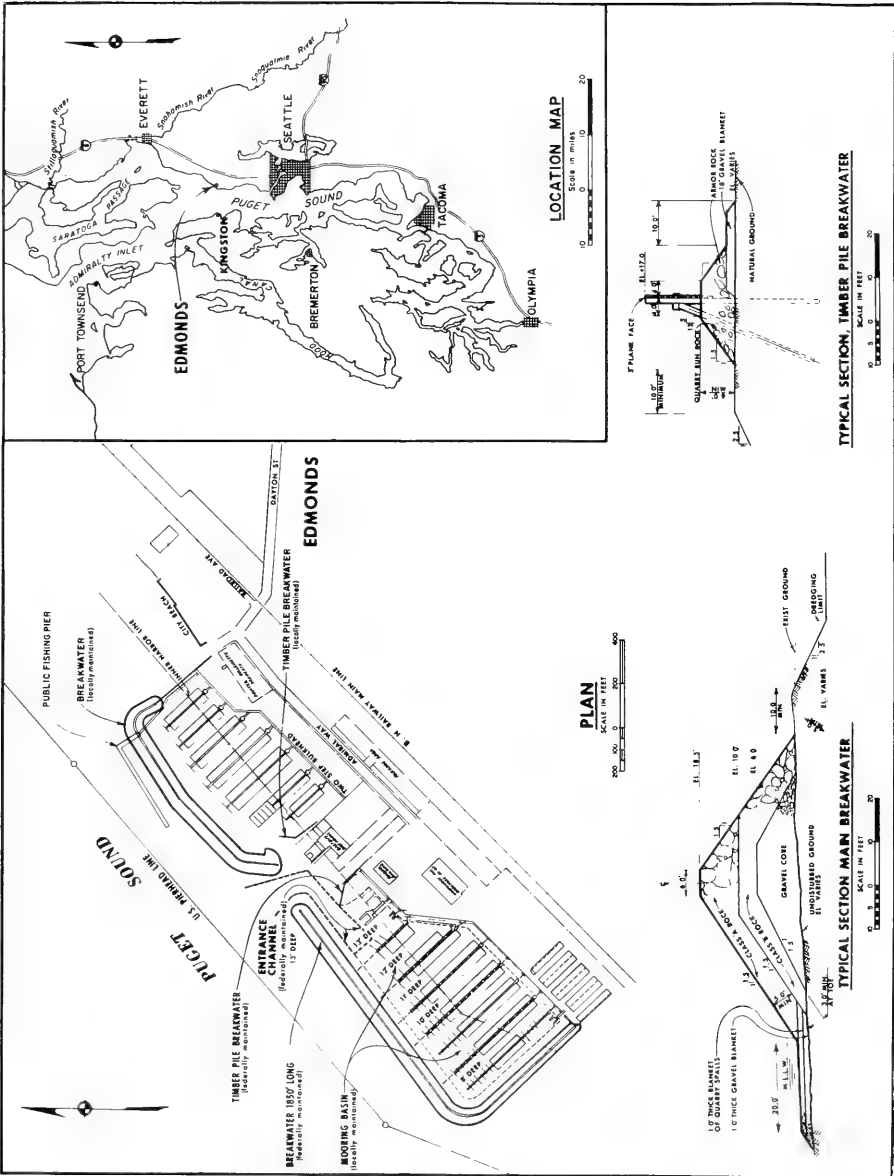
Figure 5. Edmonds Harbor Breakwaters, Washington

14. As of August 1985 plans were being developed for the repair of the rubble-mound breakwaters at Edmonds Harbor, Washington (Figure 5). It is not definitely known that toe stability was a cause of some of the existing damage, but it is thought to be a probable cause. The bottom drops off on a 1V:2H slope to a deep depth just out from the toe of the breakwaters. There is some thought that this deep water adjacent to the structure, which allows large amounts of wave energy to reach the structure, could be initiating toe stability problems. No firm decisions had been made on the repair design when this report was being prepared.

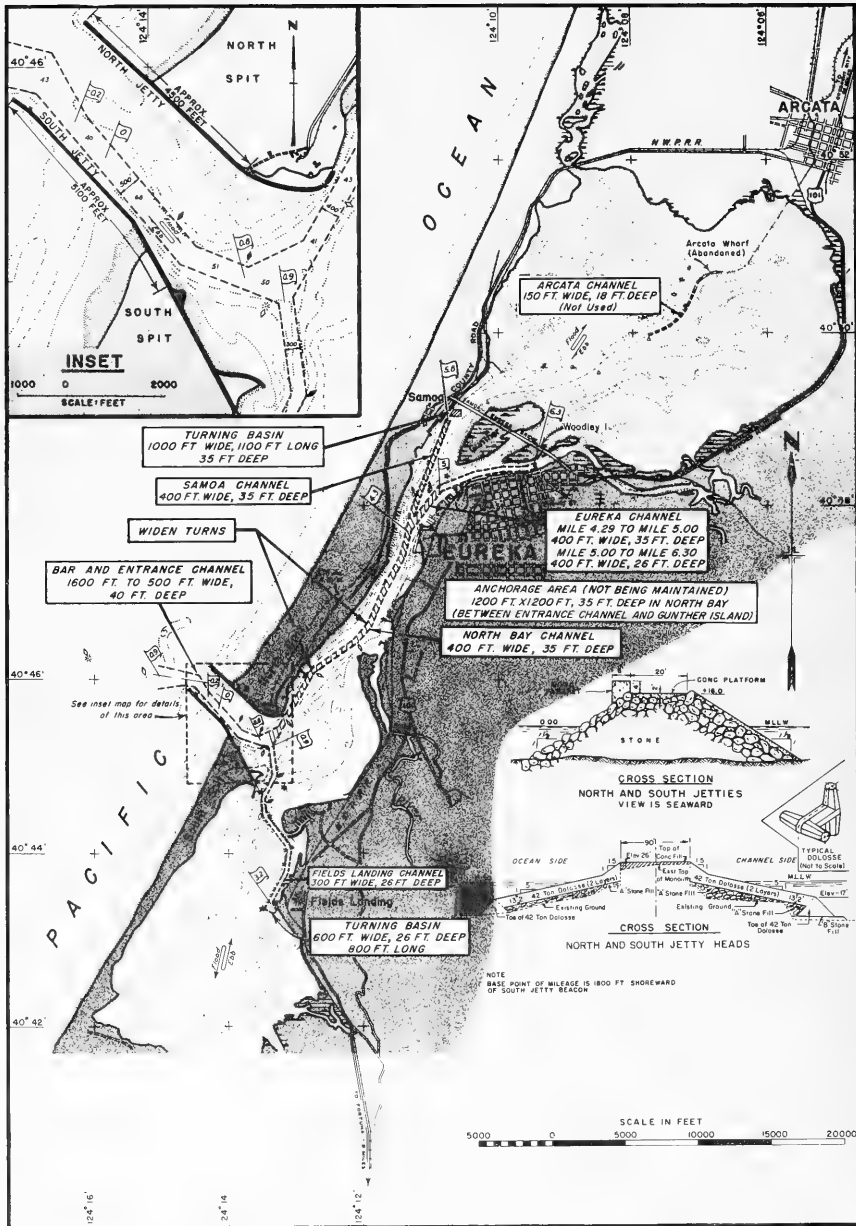
Figure 15. Humboldt Bay Jetties, California

16. The San Francisco District sited the jetties at Humboldt Bay (Figure 15) as being the only area showing obvious toe stability problems. The channel side of the north jetty and exposed side of the south jetty have shown obvious signs of scour and undermining which resulted in instability and slippage of the dolos toe. Condition surveys of the area have revealed the depths of the scour holes appear to have a seasonal fluctuation. An armor stone berm, extending from 70 to 100 ft out from the existing dolos toes, was included in the jetty repair work conducted in 1985. The multilayered berm consists of a 3- to 6-ton primary armor stone overlying two graded filter layers (Figures 16 and 17).

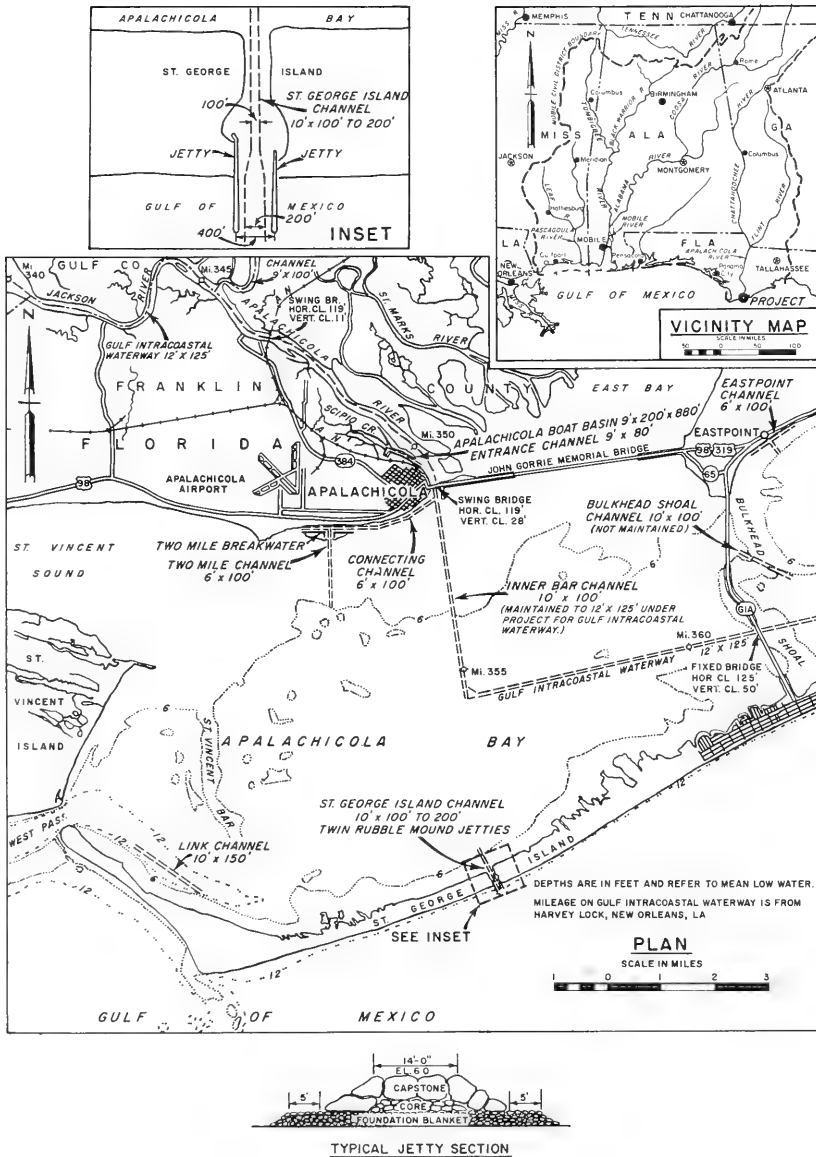
Figure 24. St. George Island Jetties, Florida

22. Jetties at St. George Island have suffered cover stone loss resulting from the undermining action of toe scour. The west jetty at Perdido Pass presently has significant amounts of toe scour on the channel side, and Hurricane Frederick produced significant amounts of toe scour on the east jetty. The overall condition of the Perdido Pass jetties was said to be good; therefore, it is assumed that the toe scour has not caused any obvious damage above the waterline.

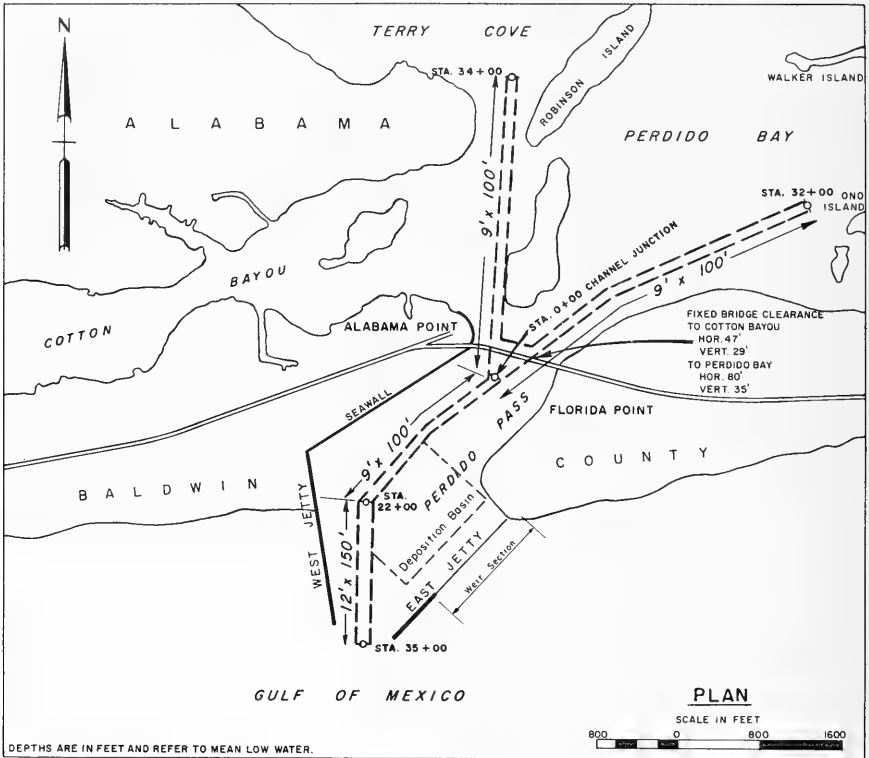
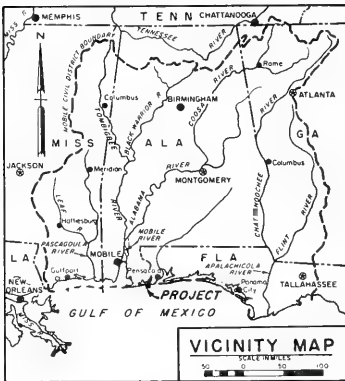
Figure 25. Perdido Pass Channel Jetties, Alabama

21. Toe scour also has been noted as a problem with the jetties at East Pass Channel and St. George Island, Florida, and Perdido Pass Channel, Alabama (Figures 23-25, respectively). Scour on the channel side of the east jetty at East Pass is so severe that it is thought that portions of the jetty may slide into the channel at any time. In the past, this type of slippage failure has caused severe damage to the west jetty at Panama City.

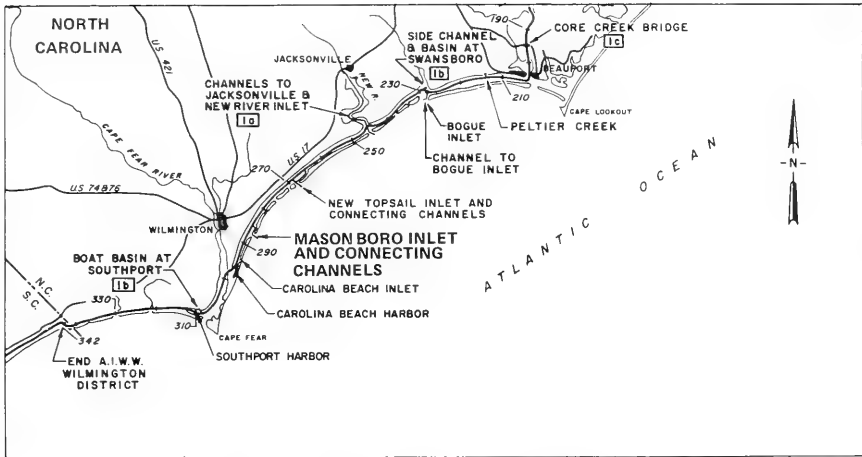
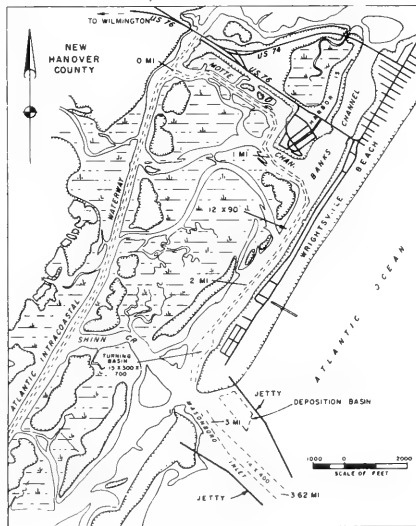
Figure 26. Masonboro Inlet Jetties, North Carolina

23. The 3,650-ft-long rubble-mound north jetty located at Masonboro Inlet, North Carolina (Figure 26), was constructed between August 1965 and June 1966. The north jetty required extensive repair on the channel-side toe of the outer rubble-mound structure in 1969 and to the channel-side toe of the inner weir section in 1973. This was prior to construction of the south jetty (14- to 22-ton armor stone) in 1980. It was thought that ebb and flood flows had caused the channel to move adjacent to the north jetty, creating the scour problem. In both repairs, a 2- to 3-layer protection of bedding material and riprap (25 to 2,000 lb) was used. This toe protection butted against the existing armor stone toe or sheet-pile weir. The berm width varied from 30 to 50 ft. It is thought that this work had limited success because the jetty has not totally deteriorated, but it is presently in need of repair work in several areas. Presently it is unknown whether the deteriorated appearance of the north jetty results from a toe scour problem or from the possibility

that the original 7- to 12-ton armor stone may have been an inadequate design for the incident wave environment.

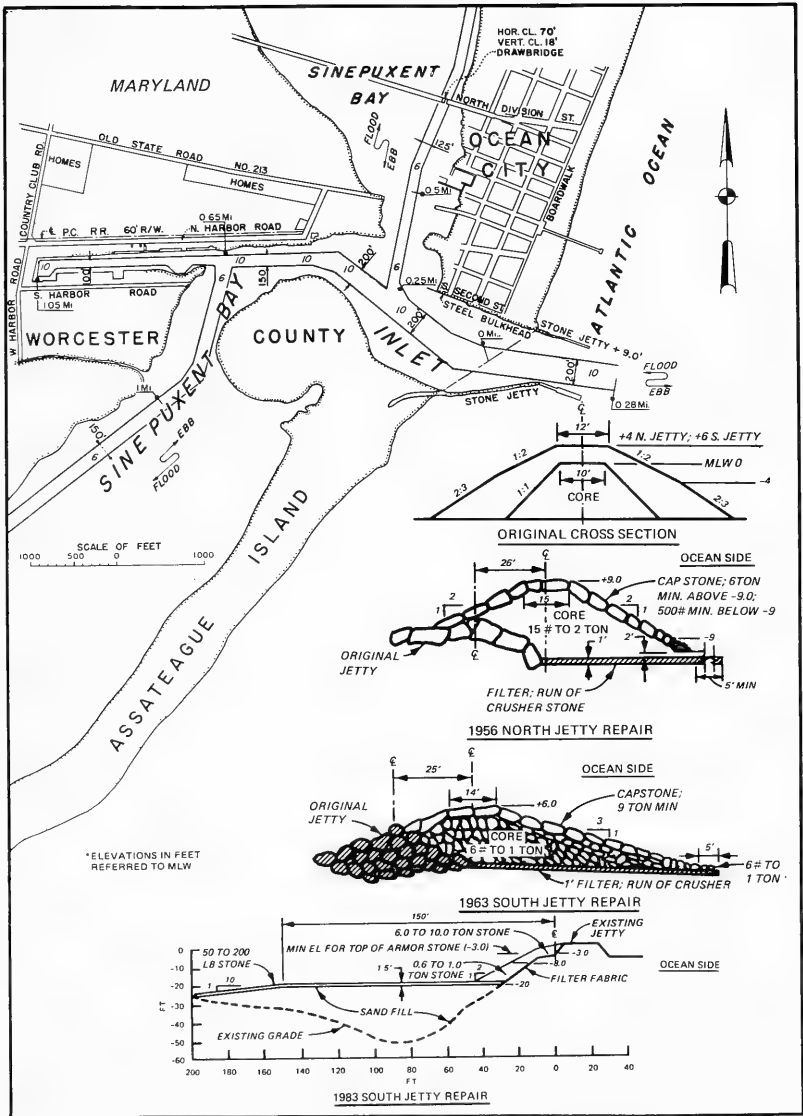
Figure 27. Ocean City Inlet Jetties, Maryland

24. The south jetty at Ocean City Inlet, Maryland (Figure 27), is the only structure within the Baltimore District that was reported as having significant toe stability problems. The original north and south jetties, both rubble mound, were constructed in 1934 and 1935, respectively. The crown elevation on the shoreward end of the north jetty had to be increased in 1937 to stop flow of sand into the inlet. The landward end of the south jetty required extensions in 1956 and 1963 to repair flanking caused by erosion. The south jetty has suffered major deterioration along its outer leg caused by ebb flow induced scour and undermining of the structure's inlet side toe. During major repair of the south jetty in 1963, the center line of the structure's repair section was offset outward from the inlet (Figure 27). This was done to alleviate the need to fill the massive scour hole that existed where the inlet side of the structure was originally constructed. The ocean side of the existing structure that remained was used as a base against which the inlet side toe of the jetty repair section was positioned. By 1982, the 1963 repair section of the south jetty was once again very deteriorated. Like the original, this damage was only on the converging portion of the jetty and was caused by ebb flow induced undermining of the structure's inlet side. In order to prevent failure of the outer end of the south jetty, which would lead to severe inlet shoaling, the scour hole adjacent to the structure was filled with dredge material and capped with stone. The lower portion of the inlet side of the jetty was overlaid with an intermediate stone size, and the remainder of the inlet side slope was covered with primary armor stone. This work was completed during 1983 to 1984, and a typical repair cross section is shown in Figure 27. The majority of the south jetty's original repair section still shows considerable deterioration and is highly overtopped. It is unknown how well the scour protection is performing. It appears that scour on the north side of the inlet has slowed down, and the north jetty is in good condition; however, the overall scour in the throat of the inlet shows no signs of stabilizing.

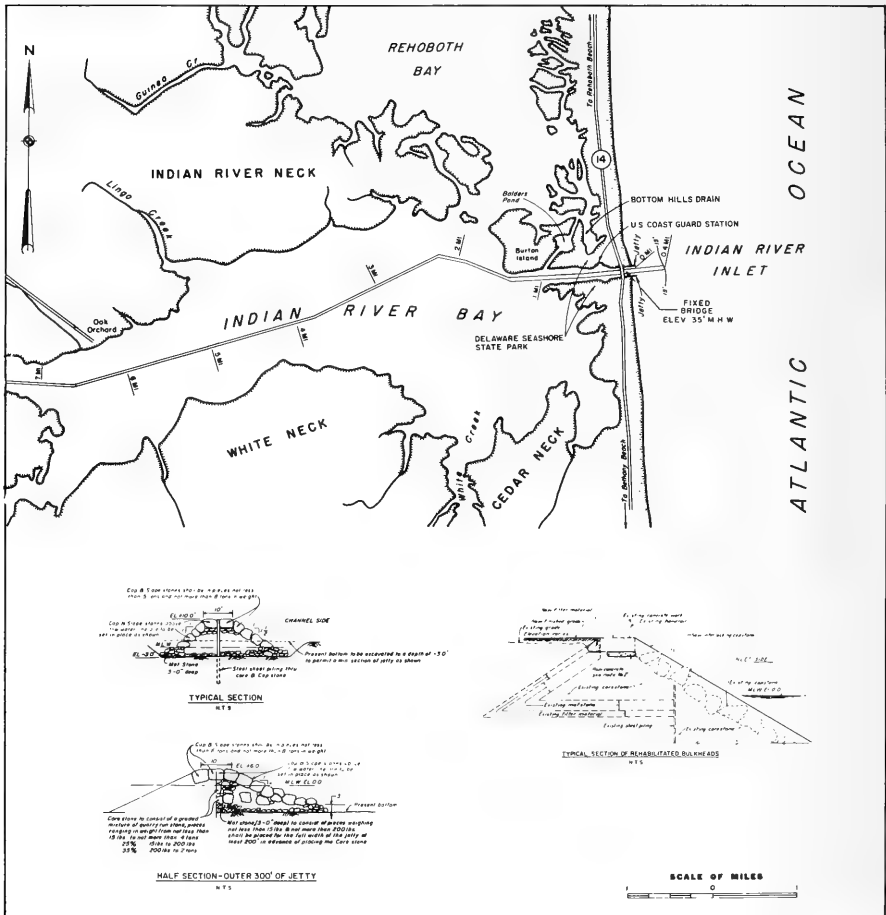
Figure 29. Indian River Inlet Jetties, Delaware

27. The rubble-mound and sheet-pile composite jetties at Indian River Inlet, Delaware, were completed in 1939 (Figure 29). The jetties required storm damage repairs in 1956 and 1957. At that time, the north jetty was extended inshore a distance of 320 ft. At present both jetties are 1,566 ft long. Both jetty heads have deteriorated significantly from a combination of toe scour, armor stone slippage and displacement, and overall subsidence. Because of the success of the Manasquan River Jetty repairs, dolosse are being considered for inclusion in the repair and rehabilitation designs for the structure slopes. No details on the proposed toe repair design are available.

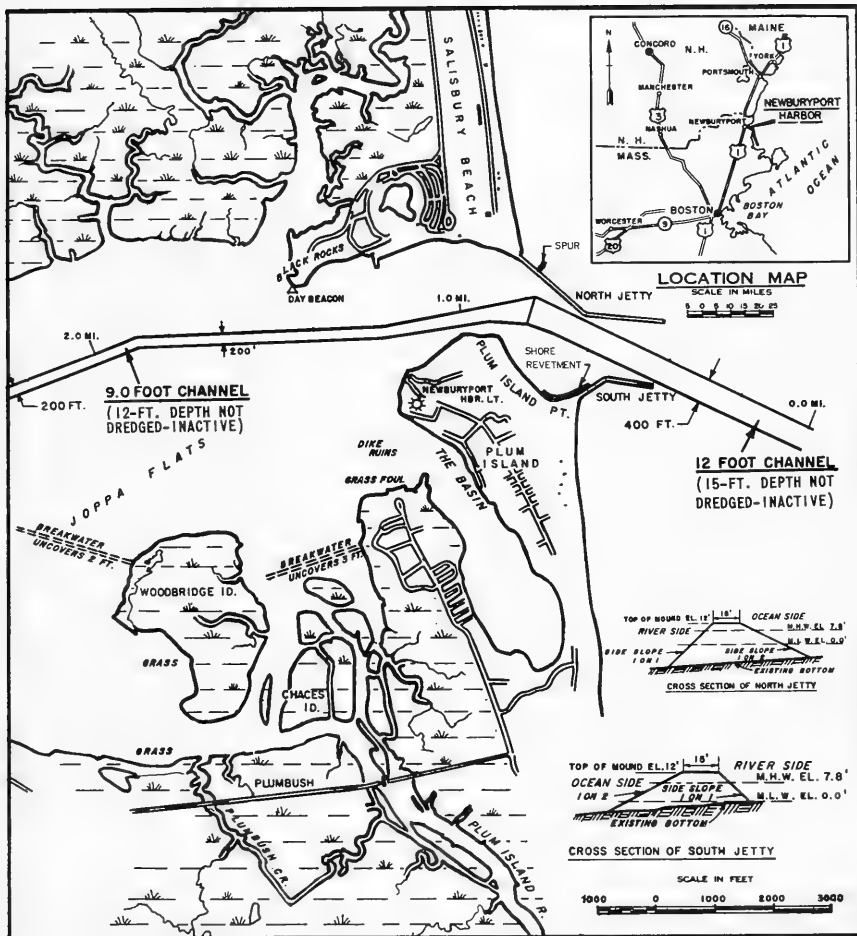
Figure 31. Newburyport Harbor Jetties, Massachusetts

28. Based on review of historical repair data, it appears that three project sites within the New England Division that contain rubble-mound jetty structures have exhibited stability problems which could be related to instability of the structure toes. Both jetties at the mouth of the Kennebec River, Maine (Figure 30), have a history of extension and repair. The latest jetty rehabilitation work was completed in 1982. Recent inspections show that both jetty heads are damaged and that 250 ft of the channel side of the east jetty have been undermined. The most recent inspection reports (1973-74), indicate that the north and south jetties at Newburyport Harbor, Massachusetts

(Figure 31), which have an extensive repair and rehabilitation history, are showing considerable damage. This damage appears to result primarily from subsidence. Damage on four areas on the channel side of the south jetty most likely result from undermining of the rubble toe. The jetties at Hampton Harbor, New Hampshire (Figure 32), were originally constructed by the State and were turned over to the Corps in 1964. During 1965 to 1966, considerable work was done on both jetties. Since that time the south jetty has remained in good condition, while the north jetty has required continuous maintenance. Most of the repair and rehabilitation work has been needed on the seaward portions of the north jetty. The last rebuilding of the north jetty was completed in 1980, and it is thought that part of this recurring damage can be attributed to scour and undermining of the jetty toe.
